#### RUDDER FENCE

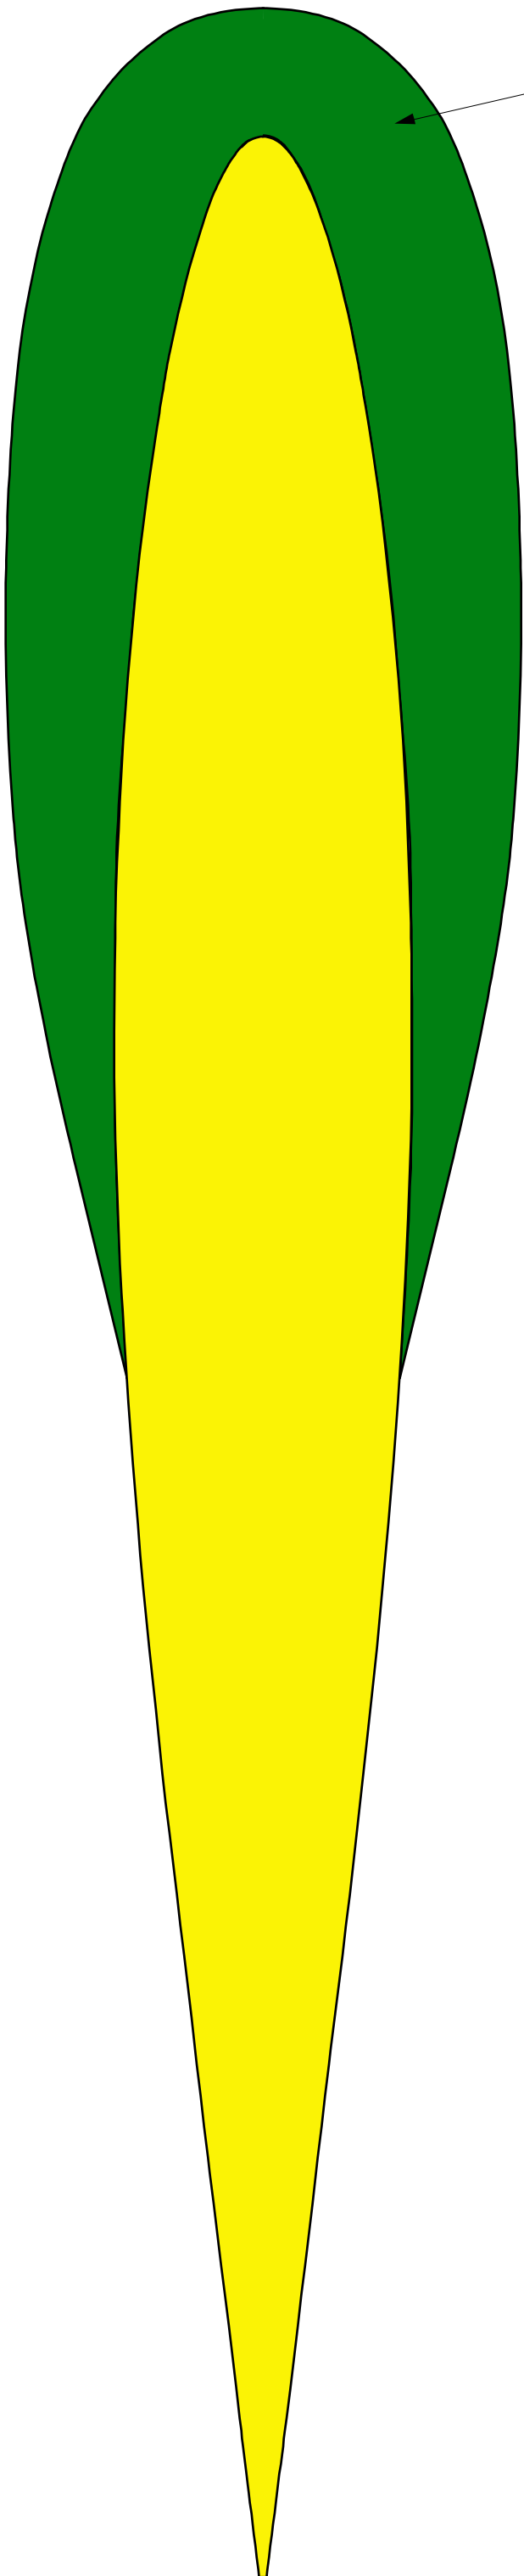
To prevent high speed ventilation. Can be made from a fiberglass or plastic sheet, 1/8" to 1/4" thick, shaped to fit around rudder and bonded in place. Should be parallel with waterline to minimize drag.

Many F-boats are now capable of speeds in excess of 20 knots, and rudder ventilation problems can arise at these speeds. Rudder ventilation is caused by waterflow being unable to stay attached to the blade when it is turned at high speed, with air then being sucked down the rudder blade. This will result in a loss of steering control, and the usual obvious symptom is a 'whoop' noise from the rudder area, a large rooster tail, and the rudder immediately feeling mushy. Control can usually be restored by centering rudder blade and wiggling slightly to reattach water flow. However, at sustained high speeds, ventilation can become a major nuisance.

To minimize, always keep the leading edge of the rudder smooth and fair, and keep the boat balanced so that it sails straight, without needing much rudder input. If ventilation becomes a consistent problem then one cure is a horizontal 'fence' on the leading edge of the rudder about 12 to 16" up from the bottom. This places a horizontal barrier to any air travelling down the rudder blade past the fence, making it harder for the water flow to become detached, and allowing steering control to remain at much higher speeds.
